Greenkote treated bolts helping to repair Leadenhall Building

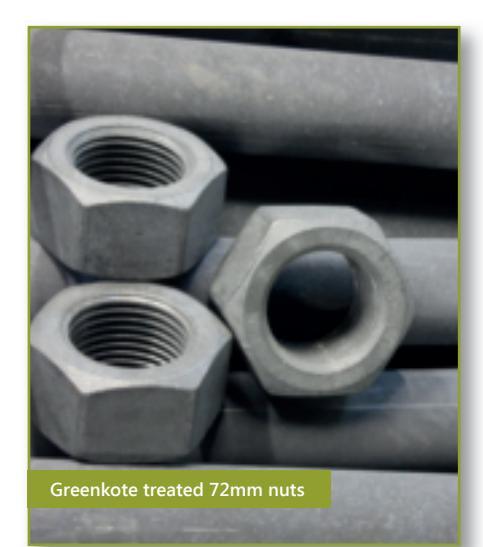
London's Leadenhall Building, or as it is more popularly known, the "Cheesegrater" hit the headlines again recently when news emerged that three of the giant studs securing the exoskeleton had suddenly snapped and fallen, in one case from the 15th floor, before landing on the ground.

An analysis of the problem revealed the cause of failure at the Cheesegrater as hydrogen embrittlement, which occurs when hydrogen atoms diffuse into the steel and weaken the overall molecular structure, making it brittle and subject to sudden failure. Hydrogen embrittlement generally occurs from exposure to acids during the forming and manufacturing process. Hydrogen exposure can occur during cleaning (pickling), welding and coating. Often, corrosion

protection coatings for steel, such as electroplating or hot-dip galvanizing are the culprits in inducing hydrogen embrittlement. However, as the original Cheesegrater studs were not galvanized, hydrogen embrittlement most likely resulted from another source in the manufacturing process.

UK fastener specialists TC Bolts were commissioned to identify a suitable solution and specified Greenkote treated fasteners to replace the damaged and missing studs. Greenkote treated bolts are widely used in challenging engineering environments, such as in the assembly of the new safe containment shelter to encase the Chernobyl reactor in the Ukraine.

Mark Gore, CEO of Greenkote commented, "Greenkote's thermal diffusion process offers exceptional corrosion protection and critically in this instance, protection against hydrogen embrittlement, as the coating process does not use aggressive acids at any stage. We are delighted that our system has been chosen to help repair this iconic new building so helping to ensure its success as a significant London landmark."
